**LEVEL 2 REPLACEMENT RESERVE REPORT FY 2022
WATERFORD CONDOMINIUM**

WATERFORD CONDOMINIUM

KENSINGTON, MARYLAND

February 26, 2021

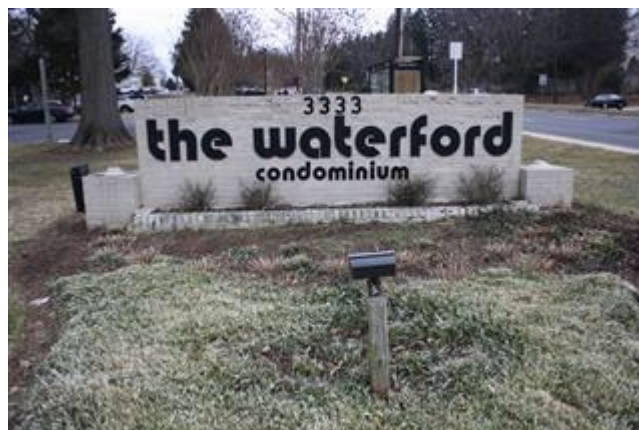
The monument lettering is metal and is considered a long-life item, therefore, excluded from this study.

We recommend repointing and replacement of defective areas of the masonry as needed. The Association may want to consider applying a coating of Siloxane or other appropriate breathable sealants to mitigate water penetration and further degradation of the masonry work.

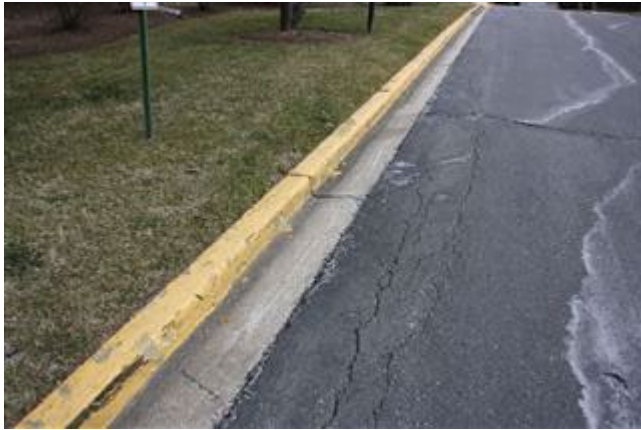
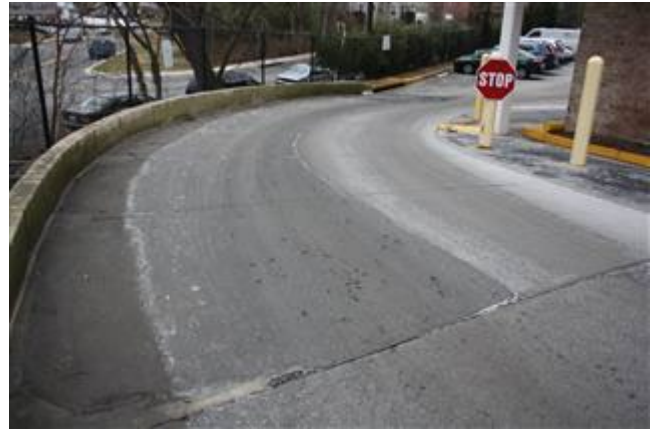
Concrete Work. The concrete work includes the community sidewalks, curbs, and gutter as well as other flatwork. The overall condition of the concrete work is in good condition.

The standards we use for recommending replacement are as follows:

- Trip hazard, ½ inch height difference.
- Severe cracking.
- Severe spalling and scale.

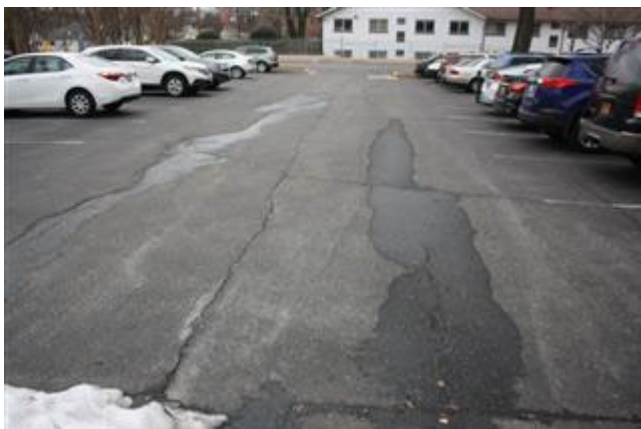
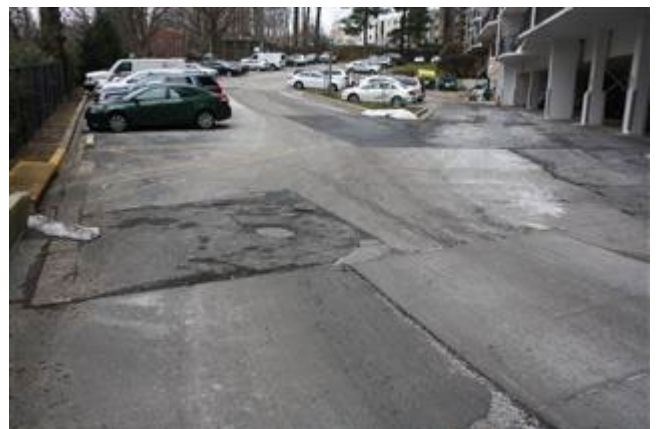
Asphalt Pavement. The Association is responsible for the parking areas within the community. In general, the Association's asphalt pavements is in poor condition.

The Defects noted include the following:

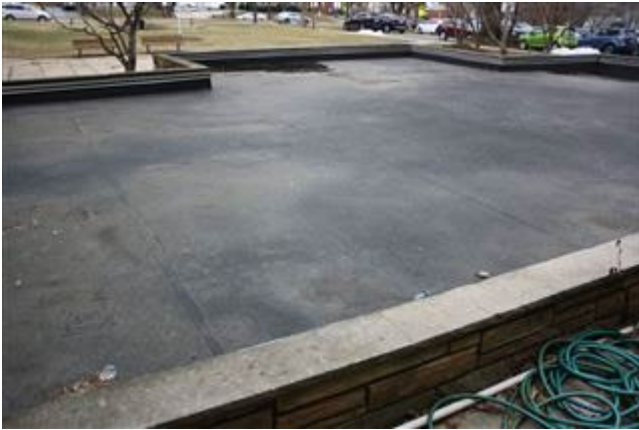
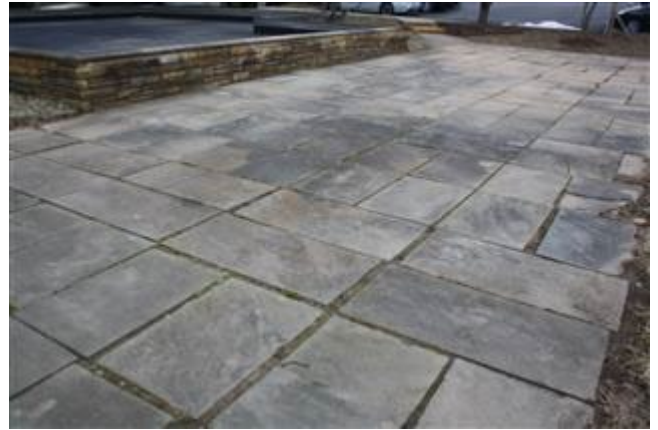
Fountain. The Association maintains a decorative fountain. The fountain has a concrete structure and is surfaced along its perimeter with stone. The fountain is lined with a waterproof coating. A 1.5 horsepower pump powers the fountain. All components are reported to be in working order.

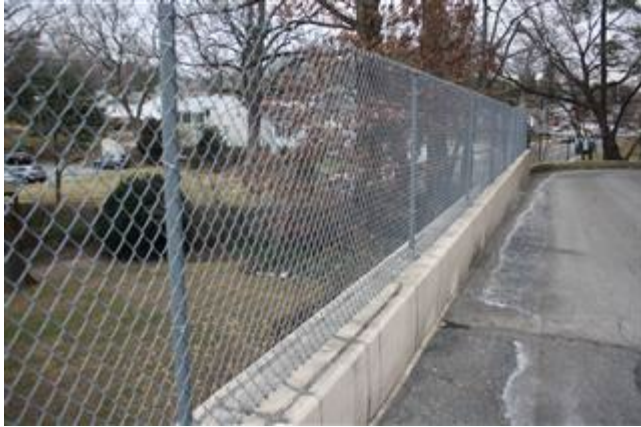
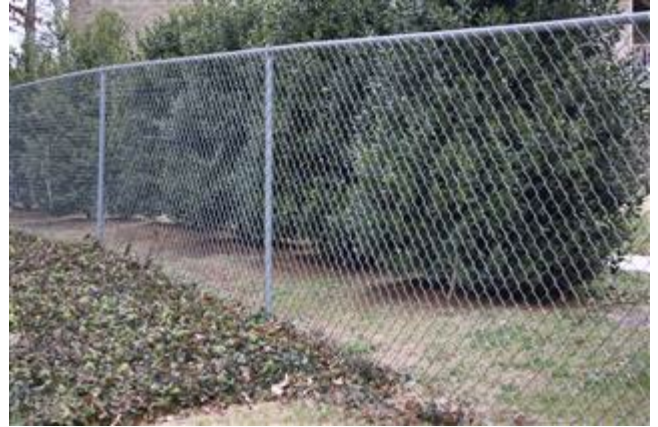
Fencing. The Association maintains chain link fencing which is in fair condition. Fencing systems have a large number of configurations and finishes that can usually be repaired as a maintenance activity by replacing individual components as they become damaged or weathered.

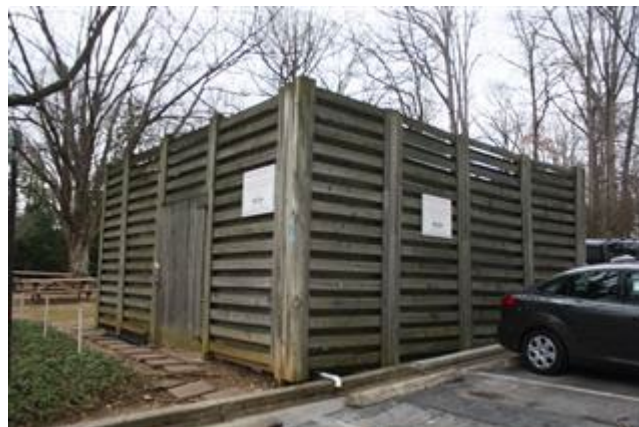
Cooling Tower Enclosure. The building's cooling tower is located on ground level at the rear of the building. The tower is enclosed in a wooden fence. The enclosure needs to be expanded for the new generator.

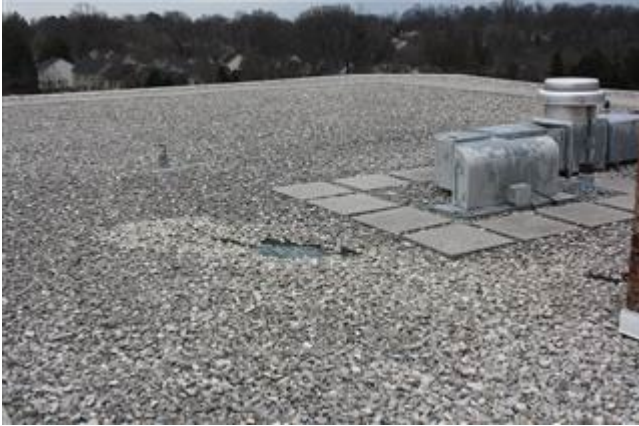
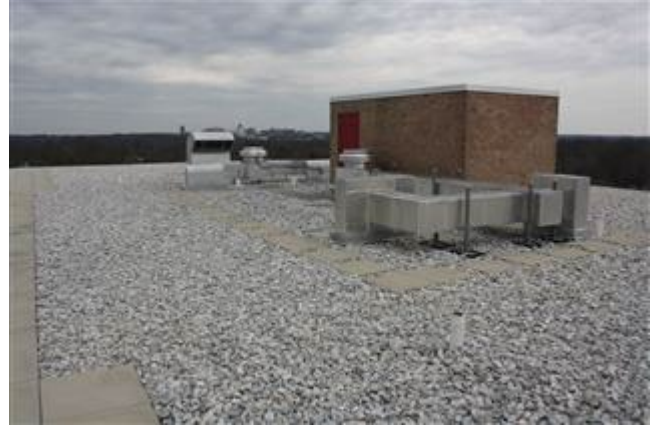
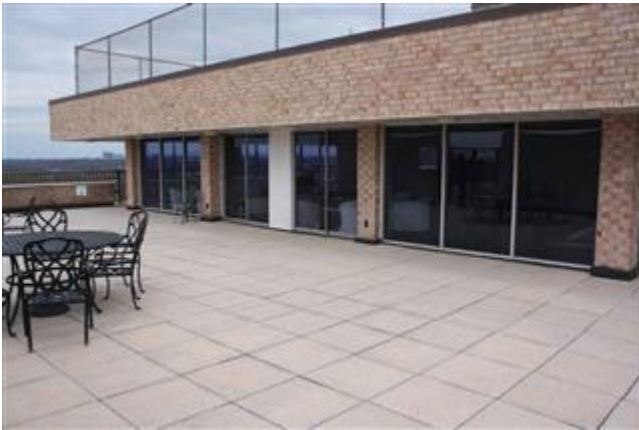
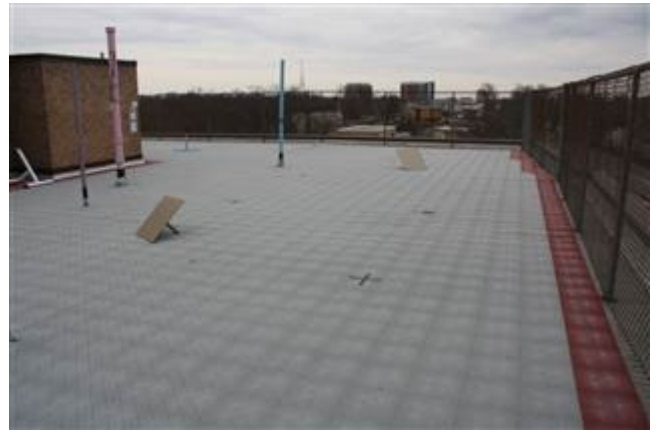
Building Roofing. The building is constructed with both an EDPM and Inverted Roofing system which are in good condition.

Flat roofing systems can have a variety of configurations that will greatly affect the cost of replacement including insulation, ballast, the height of the building, and the density of installed mechanical equipment. Flat roofing systems typically have a useful life of 15 to 25 years.

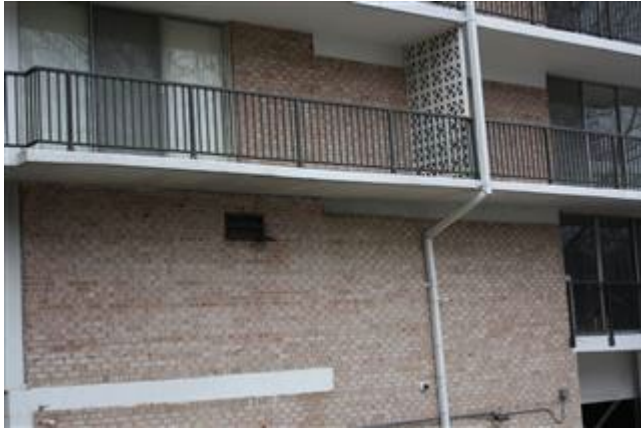
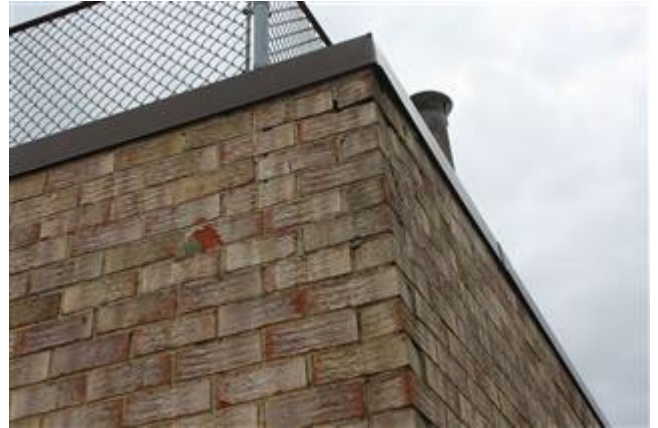
Masonry. The brickwork on the building is in good condition.

Brick masonry is used as an accent exterior cladding of the building. As masonry weathers, the mortar joints will become damaged by water penetration. As additional water gains access to the joints, repeated freeze-thaw cycles gradually increase the damage to the mortar joints. If allowed to progress, even the masonry units such as brick can have their surfaces affected and masonry units can become loose.

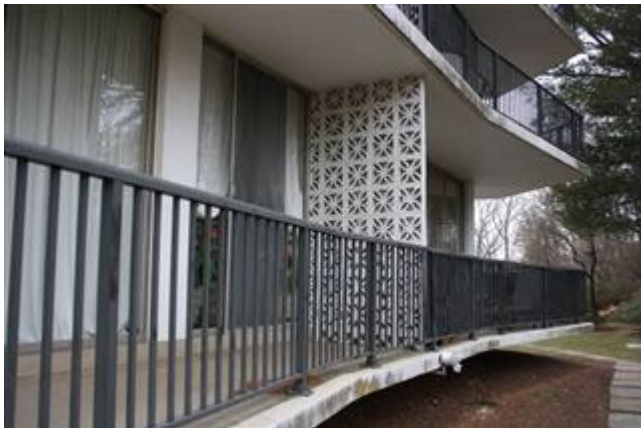
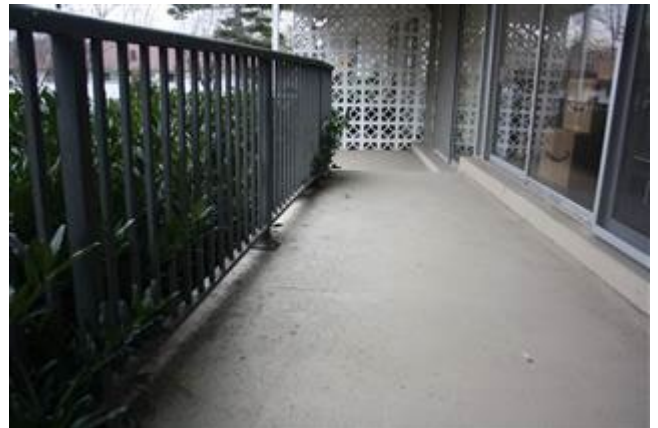
Concrete Balconies. The Association maintains the concrete balconies of the building. The structural concrete balcony decks are in good condition, and the railings are in good condition.

We noted no significant defects. The balcony surfaces are coated.

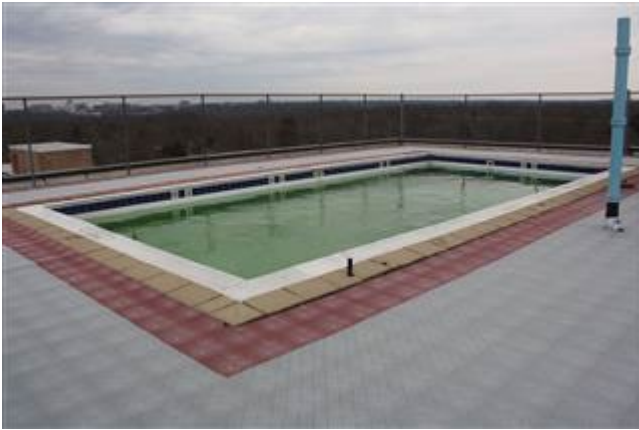
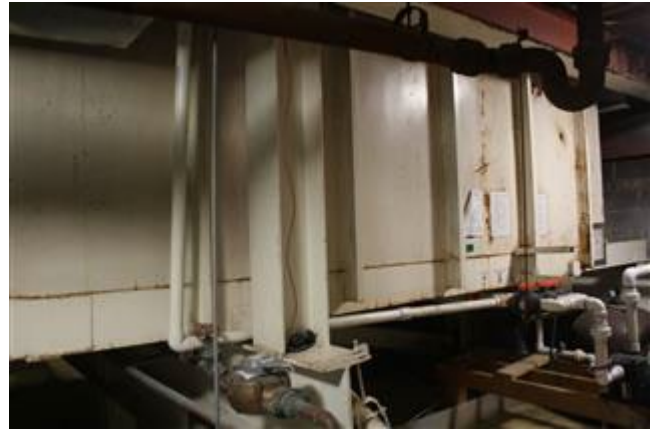
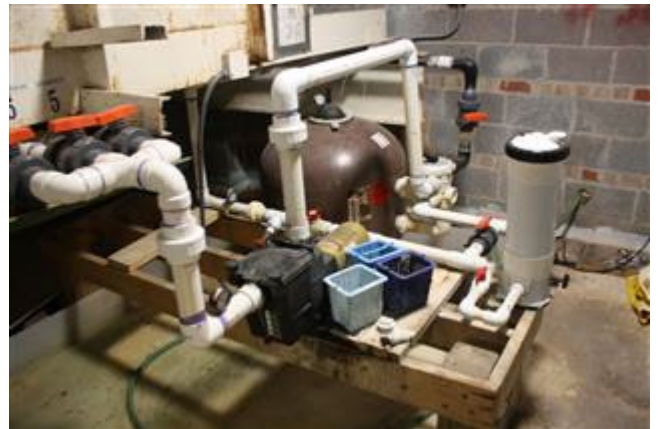
Swimming Pool. The community operates a rooftop steel-framed outdoor pool. Listed below are the major components of the pool facilities:

- Pool Shell. The steel framing shell for the swimming pool is in good condition.
- Pool Deck. The pool deck is an Inverted Roofing System with pavers as the ballast system. There is a plastic mat system on the pavers in the walking area around the pool. The overall condition of the deck is fair condition with tripping hazards.
- Fiberglass Coating. The fiberglass coating is in good condition. We have assumed service life of 45 years for the fiberglass coat.
- Waterline Tile. The waterline tile is in good condition. We have assumed that the waterline tile will be replaced or restored when the pool is refiberglassed.
- Coping. The pool is edged with precast coping. The coping is in good condition.
- Pump and Filter System. The filter system is in good operating condition.
- Pool Fence. The swimming pool is enclosed by a chain-link fence that is in fair condition.

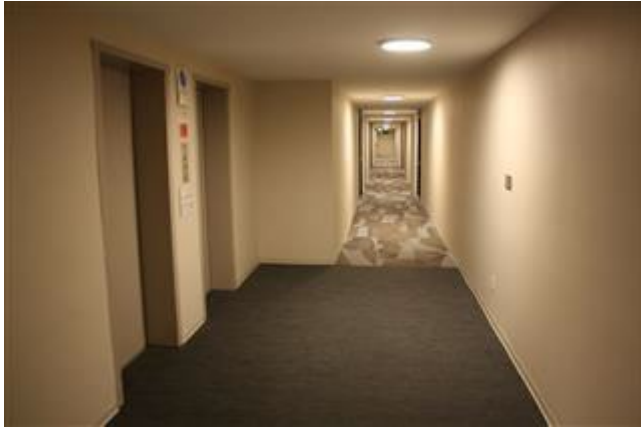
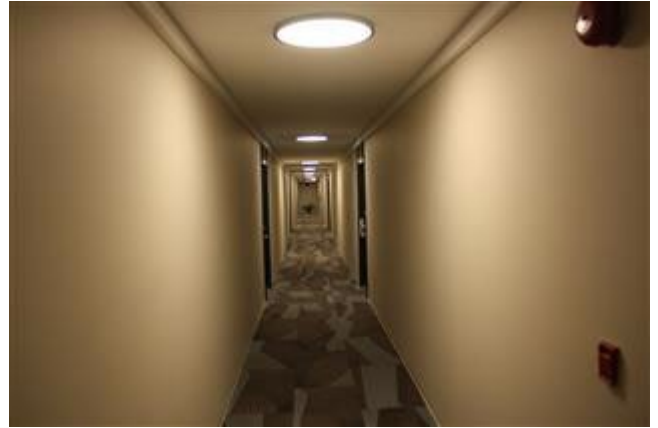
Corridors. The corridors in the building were last renovated 1 year ago. Listed below are the major corridor components that we have included in the Reserve Analysis:

- **Carpet.** The carpet in the building's corridors is in good condition. The commercial carpet of this construction in this type of application has a typical service life of 7 to 10 years.

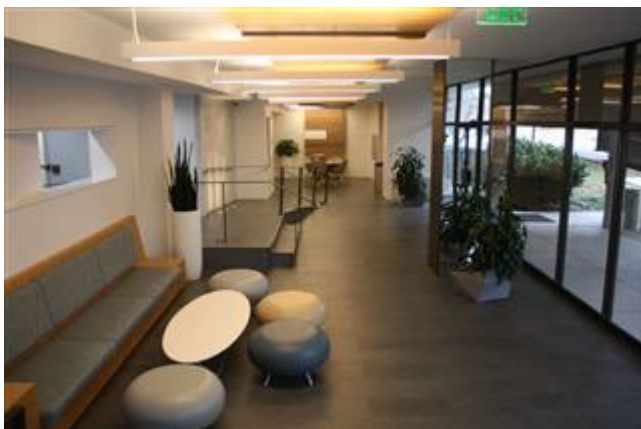
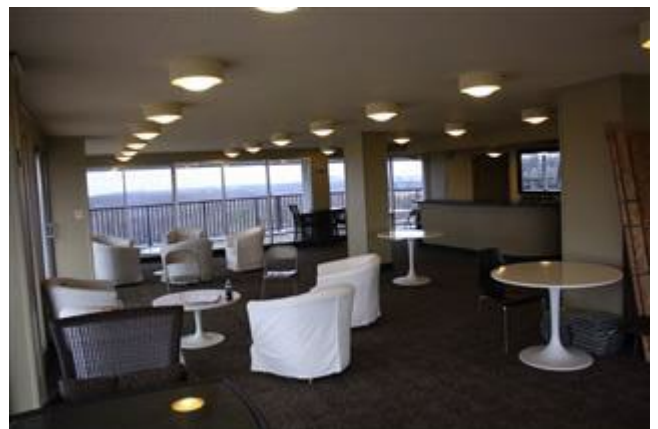
Common Interiors. The Association maintains the Lobby and Penthouse and other common interior spaces. The Lobby has been recently renovated while the Penthouse is in need of renovation.

We have assumed that the Association will want to maintain these areas in a commercially acceptable condition. Typically, replacement cycles for common interior spaces vary between 5 to 10 years depending on the aesthetic tastes of the community, usage, and construction. Material selection and the community's preferences are the major factors in setting the reserve components for items such as refurbishing and interior refurbishment. The Association will need to establish these cycles as these facilities age. Maintaining historical records and incorporating these trends and preferences into a future Reserve Study update is the best way to adjust for these cycles.

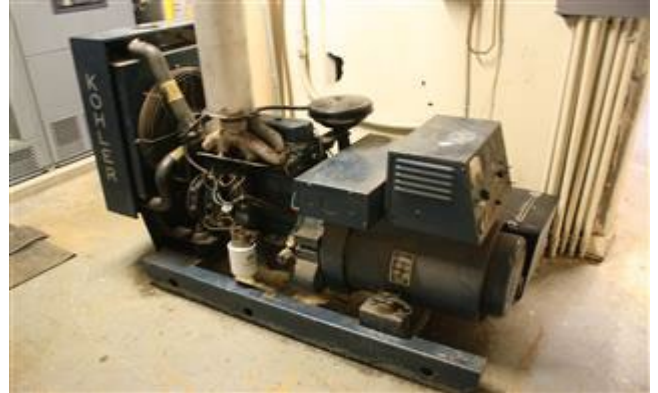
Emergency Generator. The building is served by a 25 kW generator that is located location. The generator is approximately 25 years old and is in fair condition.

The generator does not currently serve the elevators, so a new generator will be installed adjacent to the cooling tower. The generator supplies power to the building's corridor lighting, stairwell lighting, heating system, HVAC system pumps, elevator and, fire pump.

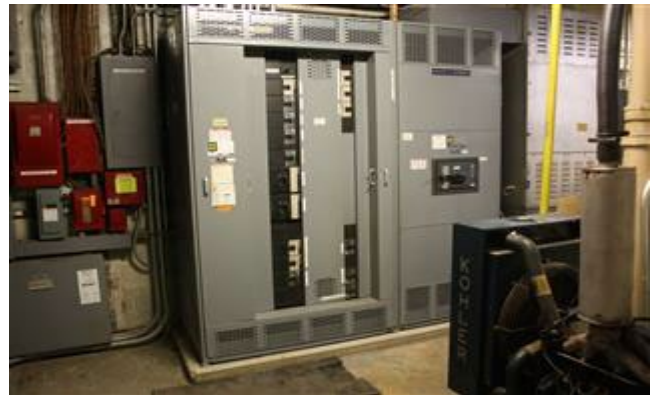
Electrical Switchgear. The electrical switchgear includes the primary distribution equipment, disconnects, relays, fuses, and circuit breakers for the facility. The primary electrical switchgear dates to the original construction of the building. Electrical switchgear has a rated service life of 50 years or more. Electrical switchgear requires ongoing maintenance for proper operation and reliability.

The overall condition of the switchgear is good. We understand that replacement parts are still available for the equipment. As the switchgear continues to age, obtaining replacement parts can be expected to become more difficult. When parts no longer are available or when the condition of the switchgear deteriorates sufficiently, the Association will have to replace or upgrade the existing equipment. Therefore, we have included funding in the Reserve Analysis for distribution panel replacement on an incremental basis.

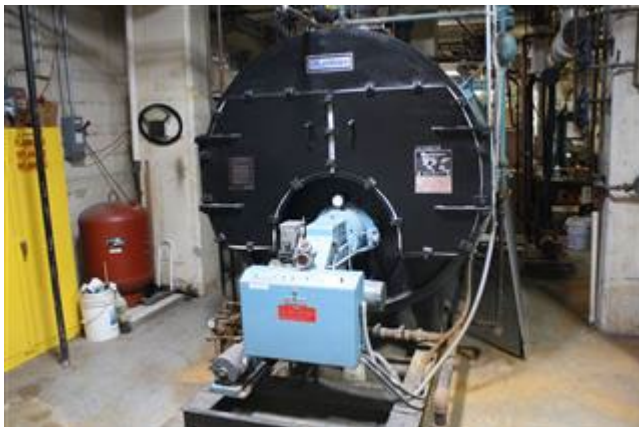
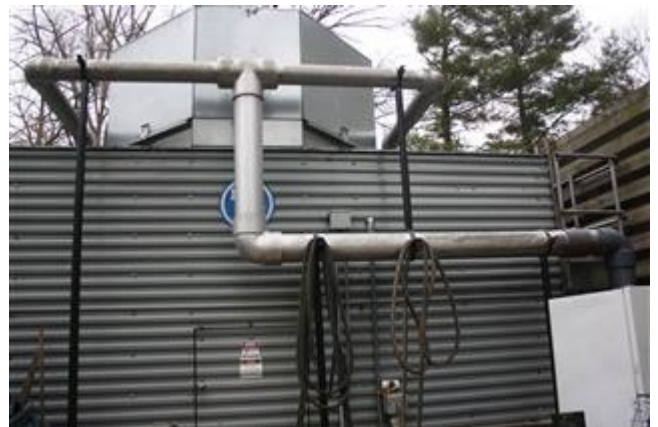
Our assessment of the condition of the boiler is based on the age of the boiler, the conditions seen during the site visit, the reported maintenance history of the boiler, and conversations with maintenance personnel. Boiler systems typically have a service life of 20 to 40 years.

When it becomes necessary to replace the central boiler system, we recommend that the community consider installing a bank of modular boilers. The use of multiple boilers will allow the operators to stage their use to match heating requirements in the building and increase the overall operating efficiency of the heating system. For additional information about modular boiler systems, please see the relevant link at <http://mdareserves.com/resources/links/building-system>.

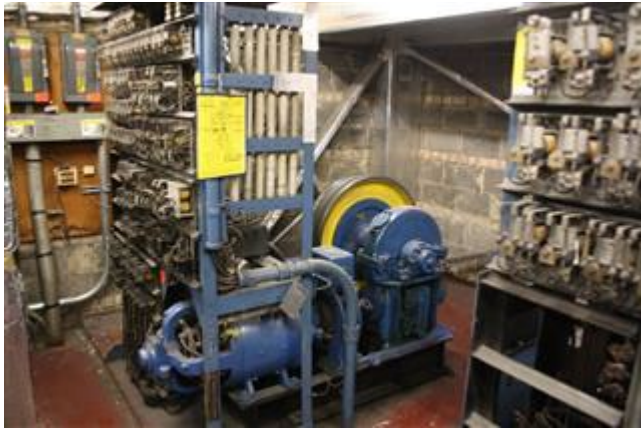
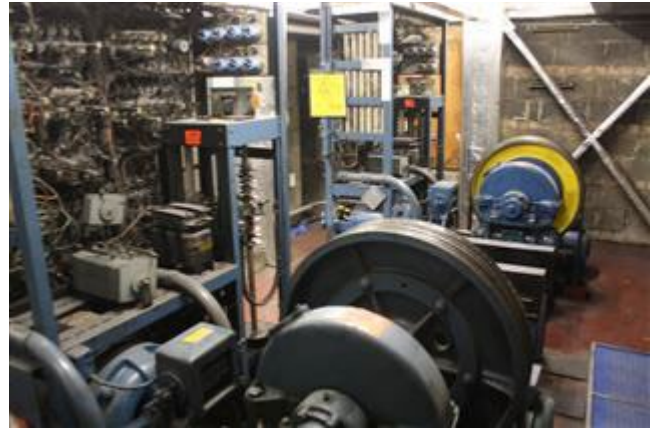
Elevators. The Association maintains three traction passenger elevators that appear to be operating normally. There are no reported cases of entrapment or operational issues by the Association.

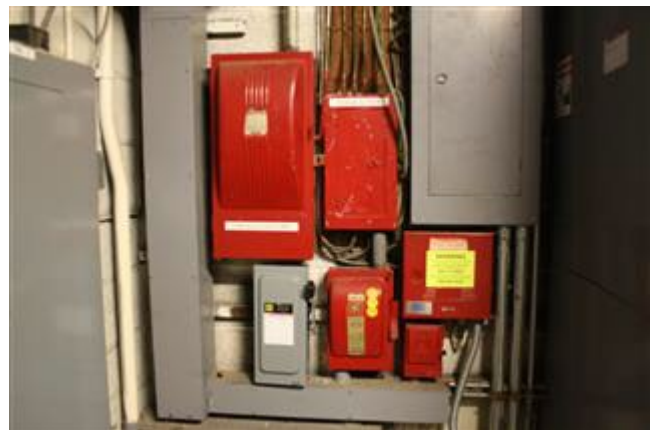
Building fire alarm systems have a service life of 15 to 25 years. While the panels may continue to operate past this point, changes in fire safety technology and building fire safety codes tend to render them obsolete. In addition, manufacturers only support their systems for a limited period, typically about 15 years. After this time, it may be increasingly difficult to obtain replacement parts and service. When it becomes necessary to upgrade the fire alarm system, differences in the technologies and new code requirements are likely to require upgrades in lighting, sensors, alarms, and other system and sub-components.

We recommend having your entire fire safety system inspected and evaluated by a professional in this field who is familiar with your area of the country. In addition, a comprehensive preventative maintenance program will ensure the maximum possible useful life from these components, and a qualified professional will be able to help in setting up and implementing such a program.
