# REPLACEMENT RESERVE REPORT FY 2017 WATERFORD CONDOMINIUM

# REPLACEMENT RESERVE REPORT

## WATERFORD CONDOMINIUM

KENSINGTON, MARYLAND  
Revised October 25, 2016

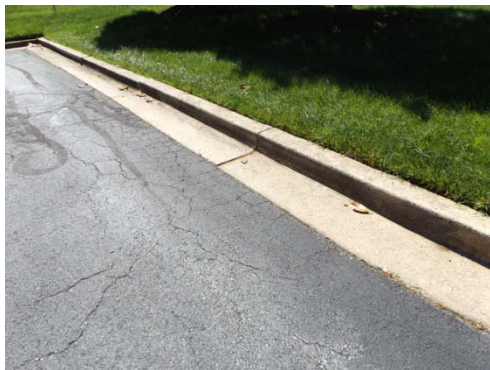
- **Tree Root Damage.** There are locations where roots from trees planted near the asphalt surface have pushed up through the asphalt, causing cracks and heaving. Repair of these areas will require removal of the asphalt and the tree roots.

Photo 1 - Cracking & alligating, typical

As a rule of thumb, asphalt should be overlaid when approximately five percent of the surface area has become cracked or has failed. The normal service life of asphalt pavement is typically 18 to 20 years.

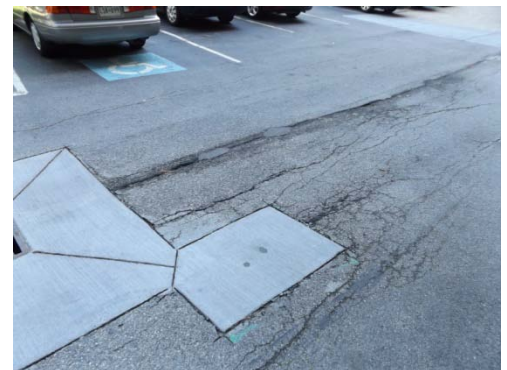
Photo 2 - Deteriorated asphalt

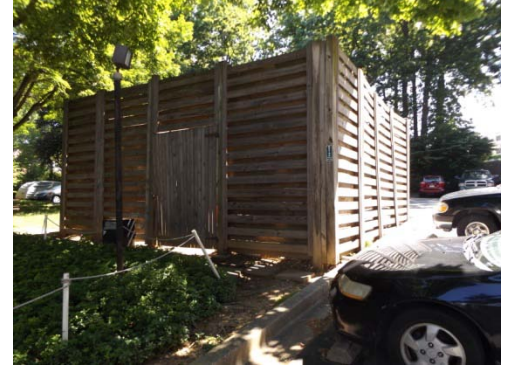
**Cooling Tower Enclosure.** The building's cooling tower is located on ground level at the rear of the building. The tower is enclosed in a wood fence. The fence is in good condition.

Photo 3 - Cooling tower enclosure

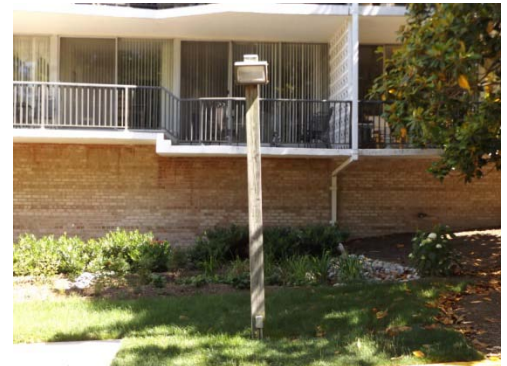
**Site Lighting.** The Association is responsible for the operation of the community's drive and walkway lights. The lighting system was not on at the time of our site visit. We understand that the lighting system is in fair to poor operating condition. It is recommended that the Association consider replacing the system with one that uses LED fixtures to reduce both maintenance and operating costs. Fixtures will have to be carefully selected to provide adequate illumination coverage given the number of trees on the property.

Photo 4 - Site light fixture

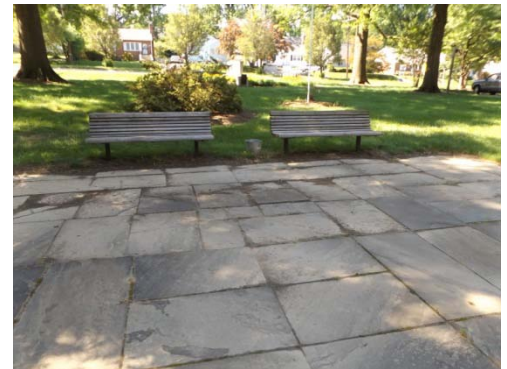
**Stone Pavers.** The community maintains an inventory of approximately 1,512 square feet of stone pavers that are part of the community's sidewalks. The overall condition of these pavers is good, with no significant deficiencies. With time and exposure to traffic, it can be expected that portions of the pavers will settle or become damaged.

Photo 5 - Pavers

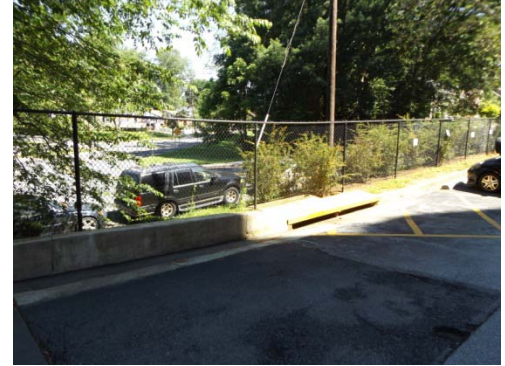
**Chain Link Fencing.** The Association maintains an inventory of 830 linear feet of five foot high chain link fencing, and 512 linear feet of six-foot high chain link fence. The overall condition of the fencing is good with only a limited number of deficiencies, such as light corrosion or damaged fence posts.

Photo 6 - Retaining wall fence

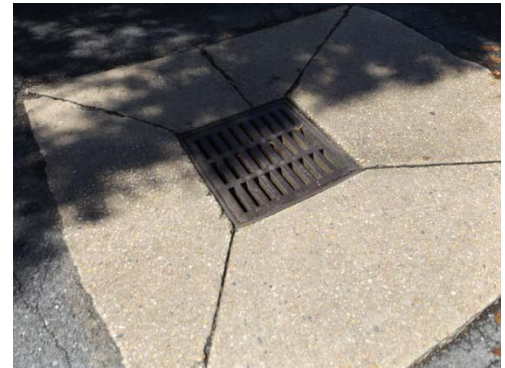
While these items are long life items, soil movement can result in displacement of the structure. Openings between the inlets and the surrounding pavement and other surfaces can result in erosion and settlement of the pavement surrounding the curb inlet. This movement results in additional settlement and erosion. Uncorrected, the entire catch basin or curb inlet will require replacement or rebuilding.

Photo 7 - Catch basin

Not all items will require rebuilding or replacement at the same time. Therefore, we have included funding in the Reserve Analysis for repairs on a periodic basis. We have assumed that one catch basin or curb inlet will require rebuilding or replacement every ten years.

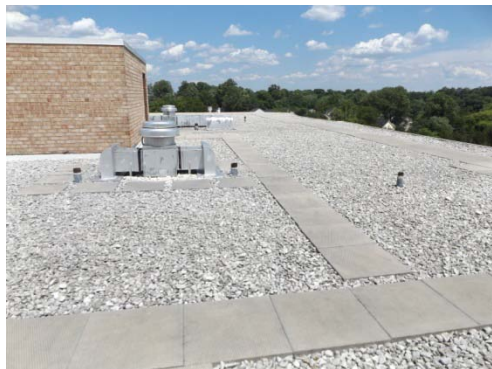
**Single-Ply Roofing.** The west section of roofing was being replaced at the time of our site visit. The remaining single-ply roof sections appear to be in good condition with no obvious signs of disrepair or ponding at this time. Although the membrane has a long life expectancy, these roofs will typically fail at the seams in the panels and around vents and other roof details. Because the rubber oxidizes over time the resealing of failed seams and joints has historically proven to be difficult, in that the oxidation inhibits the rebonding of the failed seams. Accordingly, we have included the replacement of the roof with a 20-year roof at an estimated cost of \$22 per square foot. We have estimated the remaining useful life of the roofs based on the conditions seen at the site as well as the age of the roofs. Because of the nature and age of the existing roof, we recommend the periodic inspection of the roof by a professional roofing consultant to detect early signs of failure.

Photo 8 - Inverted roof

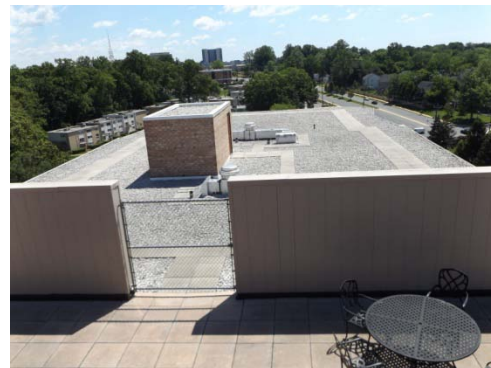
Photo 9 - Roof section being replaced

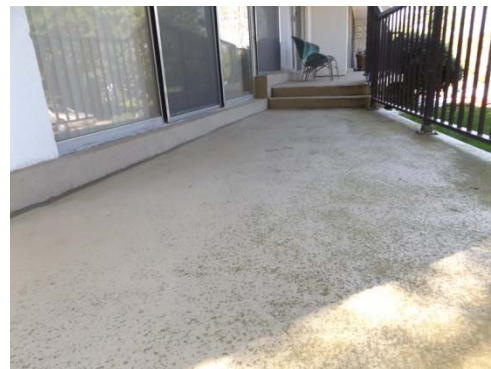
The leading cause of concrete balcony deterioration is the corrosion of the reinforcing steel. Water penetrates the concrete surface or enters the concrete through the mounting holes for the railing. When it comes in contact with the reinforcing steel, the result is corrosion. As the steel corrodes, it expands, putting

Photo 10 - Typical balcony

pressure on the surrounding concrete. This pressure can result in cracks in the concrete and spalling of the concrete surface or edge of the concrete balcony. The rate of corrosion is influenced by such factors as the thickness of the concrete over the reinforcing steel, the rate of water infiltration, and the installation of carpet or other porous materials on the balcony.

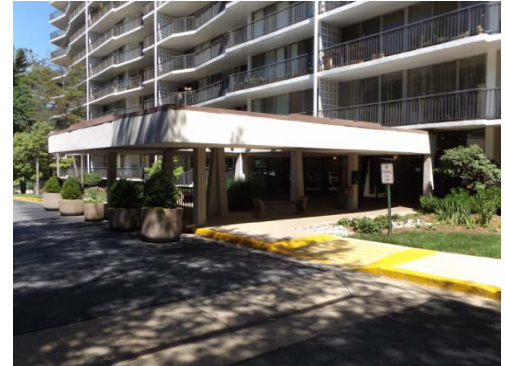
- Roof. There are signs that the portico roof is leaking. We recommend that it be evaluated by a roofing consultant.
- Exterior Insulation Finish System (EIFS). Exterior Wall Insulation and Finish System (EIFS), often incorrectly called synthetic stucco, is a lightweight, synthetic wall cladding system constructed from plastic foam insulation and several thin synthetic coatings.

Photo 11 - Portico

The EIFS was visually inspected. A number of were noted. EIFS systems have historically experienced problems resulting from faulty installation and inappropriate design details that trap moisture behind the weather barrier. These conditions have caused leaks and structural damage at other locations. Improper detailing can also cause surface cracking. These defects can only be found by close inspection from scaffolding and by removal of small sections of the material to test if moisture is present. This activity is beyond the scope of this study. We recommend periodic inspection of the building by a professional certified and equipped to conduct this type of inspection.

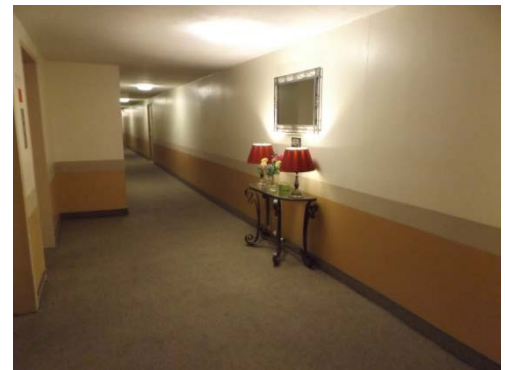
- Carpet. The carpet in the building's corridors is in fair to poor condition. Commercial carpet of this construction in this type of application has a typical service life of seven to ten years.
- Light Fixtures. Corridor illumination is provided by ceiling mounted light fixtures. The fixtures use compact fluorescent lamps. The fixtures are in fair working condition and provide adequate lighting. Fixtures of this type have a typical service life of 25 years.

Photo 12 - Typical corridor

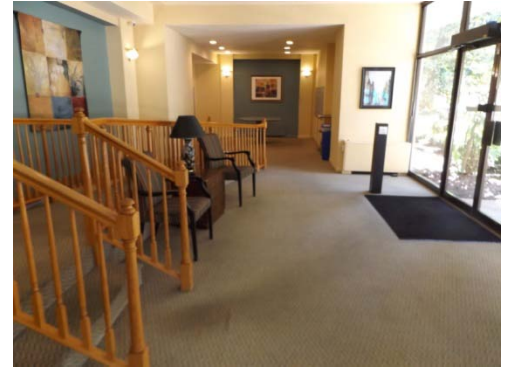
- **Mailboxes.** Although the mailboxes are in good operating conditions, they are considered to be undersized by today's standards.
- **Fan Coils.** The lobby has three fan coil units that are supplied with heating or cooling water from the building's central system. We have assumed a service life of 25 years for the fan coil units. The units are in fair condition.

Photo 13 - The lobby

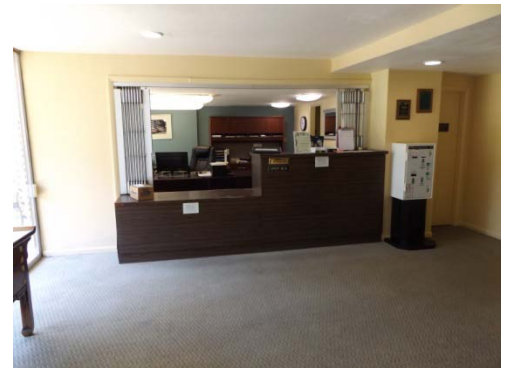
**Office Area.** The office/reception desk is in poor condition and dated. We have included funding in the Reserve Analysis for replacement of the major components in this area.

Photo 14 - Reception desk & office

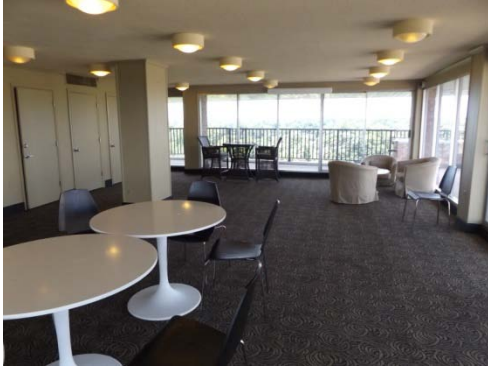
**Penthouse.** The building's penthouse includes a sitting area and a small kitchen/bar. While most of the components in the penthouse are in fair to good condition, they are dated. We have assumed that the entire area will be renovated in approximately three years. Listed below are the major components of the penthouse.

Photo 15 - Penthouse

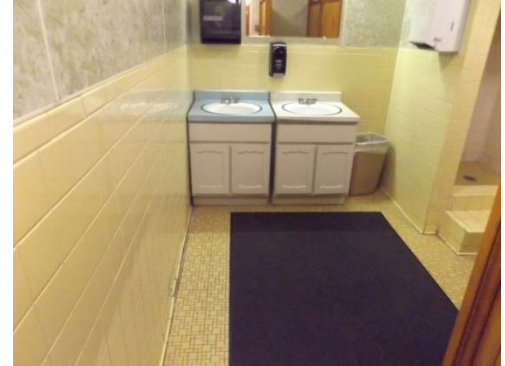
- Restrooms. The restrooms located just outside of the entrance to the penthouse are in fair to good operating condition but are badly dated.

Photo 16 - Penthouse restroom

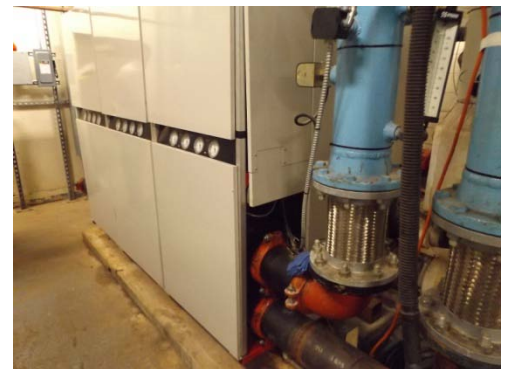
**Scroll Chillers.** Two banks of scroll chillers supply chilled water to the community. The chillers are approximately seven years old. Chillers of this type have a typical service life of 20 to 25 years. The chiller is in good operating condition. Our assessment of the condition of the chiller is based on the age of the chiller, the conditions seen during the site visit, the reported maintenance history of the chiller, and conversations with maintenance personnel.

Photo 17 - Scroll chillers

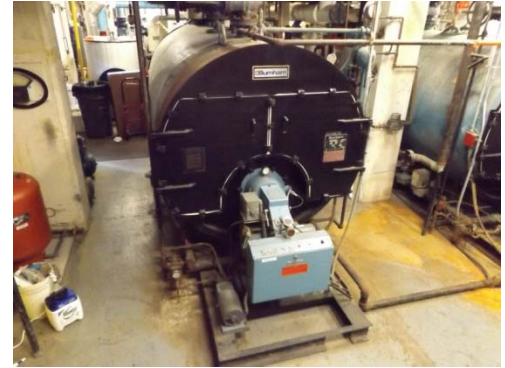
**Heating Boiler.** Heat to the building is supplied by a single, hot water boiler located in the basement mechanical room. The boiler is approximately 25 years old and is in good condition. Our assessment of the condition of the boiler is based on the age of the boiler, the conditions seen during the site visit, the reported maintenance history of the boiler, and conversations with maintenance personnel. Boilers of this type typically have a service life of 40 years.

Photo 18 - Heating boiler

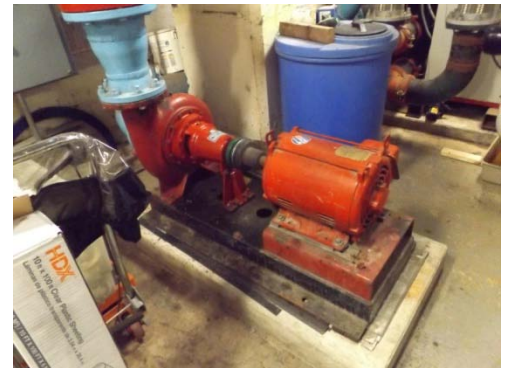
**Circulation Pumps.** There are four pumps located in the central plant that circulate the building heating, chilled, and condenser water; a 20 and a 40 horsepower pump for heating and chilled water, 20 horsepower pumps for condenser water, and a 30 horsepower standby pump. A fifth pump is a standpipe booster pump.

Photo 19 - Typical circulation pump

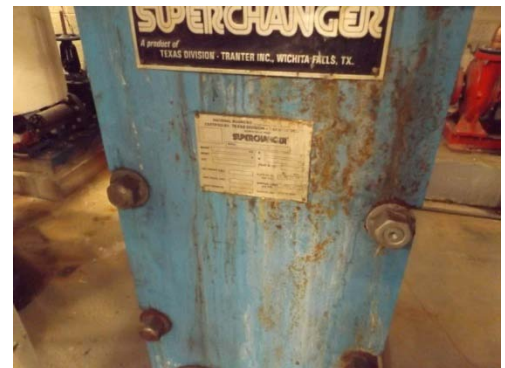
**Heat Exchanger.** Domestic hot water is generated through the use of a plate-and-frame heat exchanger attached to the central boiler system during the heating season. We understand that the heat exchanger is in fair condition.

Photo 20 - Heat exchanger

To protect the heat exchanger from fouling, sludge buildup, and leaks, it is recommended that the boiler water supplied to the heat exchanger undergo a chemical treatment program. Chemical treatment helps to eliminate the contaminants that cause scale and sludge, and to protect the interior surfaces from corrosion. In addition, the heat exchanger should be removed from service once every three to five years, cleaned, and inspected.

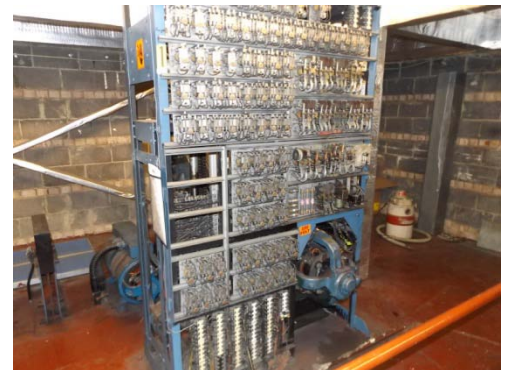
**Elevators.** The estimated cost of replacing the major components of the building elevators has been developed utilizing R.S. Means Construction Cost Data. These costs are included to reflect the obsolescence that occurs with elevator systems. Even though the systems may be functioning well at this time, parts for most mechanical control systems are becoming increasingly hard to find. Parts availability becomes a major consideration that forces a replacement decision. When this work is ultimately accomplished, the elevators will have to be brought into compliance with the latest safety code requirements. This work typically entails upgrading door operating mechanisms, replacing elevator call systems, and installation of emergency phones. A prudent amount has been included in anticipation of these problems.

Photo 21 - Elevator control relays

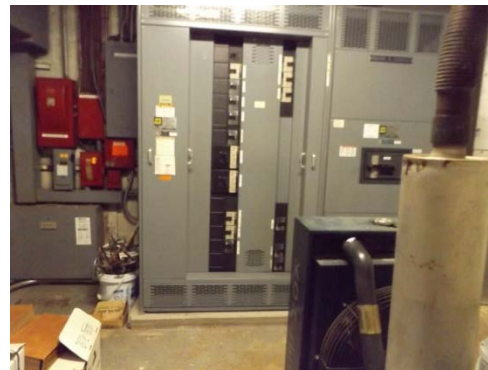
**Electrical Switchgear.** The electrical switchgear includes the primary distribution equipment, disconnects, relays, fuses, and circuit breakers for the facility. The primary electrical switchgear has been replaced. Electrical switchgear has a rated service life of 50 years or more. Electrical switchgear requires ongoing maintenance for proper operation and reliability.

The overall condition of the switchgear is good. We understand that replacement parts are still available for the equipment. As the switchgear continues to age, obtaining replacement parts can be expected to become more difficult. When parts no longer are available or when the condition of the switchgear deteriorates sufficiently, the Association will have to replace or upgrade the existing equipment. Therefore, we have included funding in the Reserve Analysis for upgrading the equipment when it is approximately 50 years old.

Photo 22 - Primary switchgear

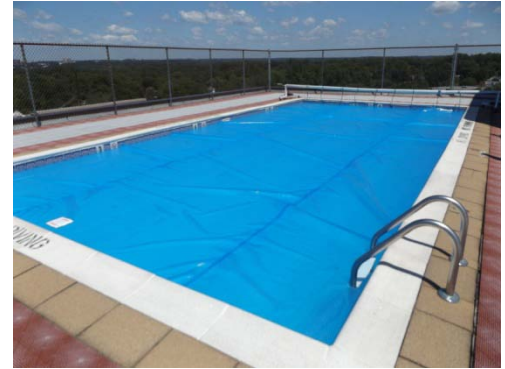
- **Pump and Filter System.** The filter system is in good operating condition. We have assumed a service life of 20 years for the filter system, and 10 years for the pump.

Photo 23 - Swimming pool

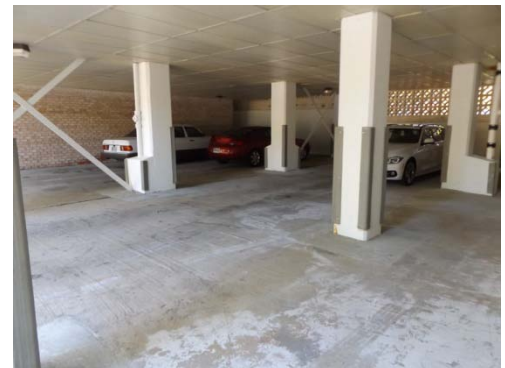
It is important that the integrity of this ceiling tile be maintained as it helps to insulate the above spaces and to protect piping installed above the tile. Any gaps or missing tile will allow cold air to penetrate the space above the tile, increasing heat loss from the conditioned space increasing the chances of freezing the piping above the tile. We recommend that the tile be inspected in the fall and after any work is completed in the space above the tile.

Photo 24 - Garage
