LEVEL 2 REPLACEMENT RESERVE REPORT FY 2021 WATERFORD CONDOMINIUM

REPLACEMENT RESERVE REPORT

WATERFORD CONDOMINIUM

KENSINGTON, MARYLAND
February 26, 2021

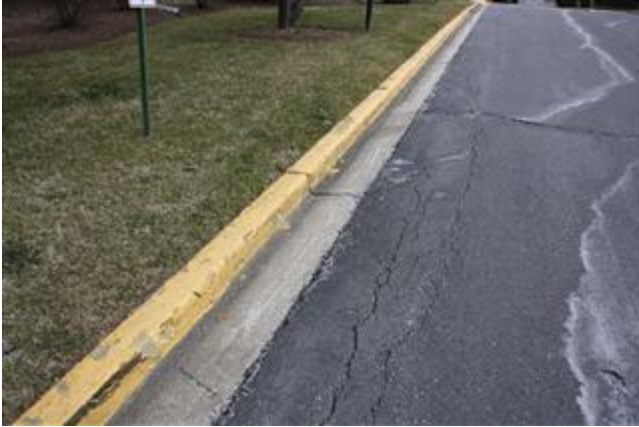
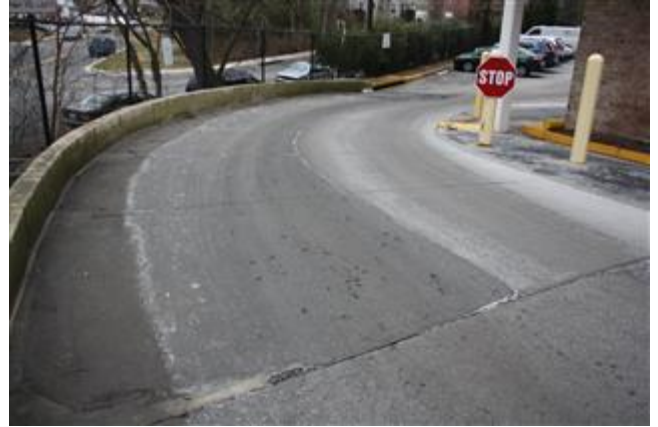
Concrete Work. The concrete work includes the community sidewalks, curbs, and gutter as well as other flatwork. The overall condition of the concrete work is in good condition.

Because it is highly unlikely that all of the concrete components will fail and require replacement in the period of the study, we have programmed funds for the replacement of these inventories and spread the funds over an extended timeframe to reflect the incremental nature of this work.

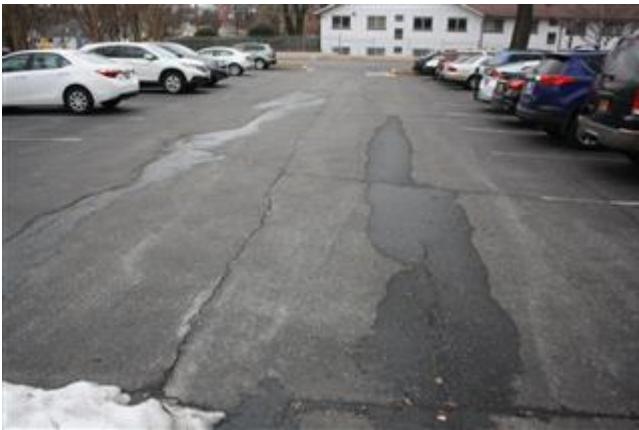
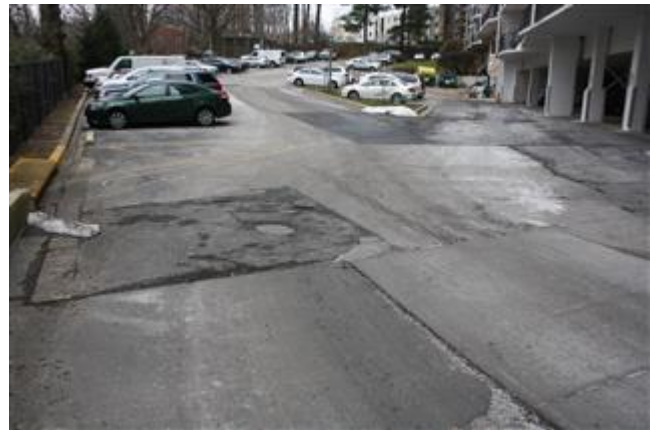
Asphalt Pavement. The Association is responsible for the parking areas within the community. In general, the Association's asphalt pavements is in poor condition.

- **Open Cracks.** There are multiple locations where open cracks are allowing water to penetrate to the asphalt base and the bearing soils beneath. Over time, water will erode the base and accelerate the deterioration of the asphalt pavement. If cracks extend to the base and bearing materials, remove the damaged areas, and replace defective materials. As a part of normal maintenance, clean and fill all other cracks.

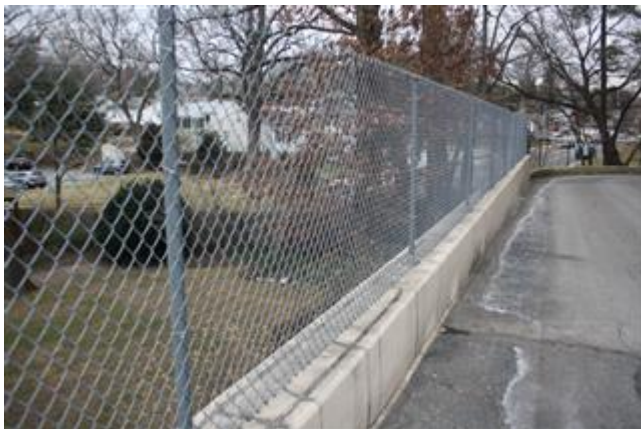
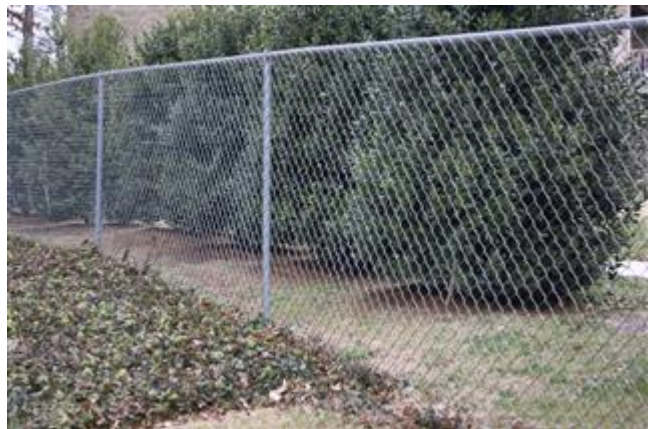
Fencing. The Association maintains chain link fencing which is in fair condition. Fencing systems have a large number of configurations and finishes that can usually be repaired as a maintenance activity by replacing individual components as they become damaged or weathered.

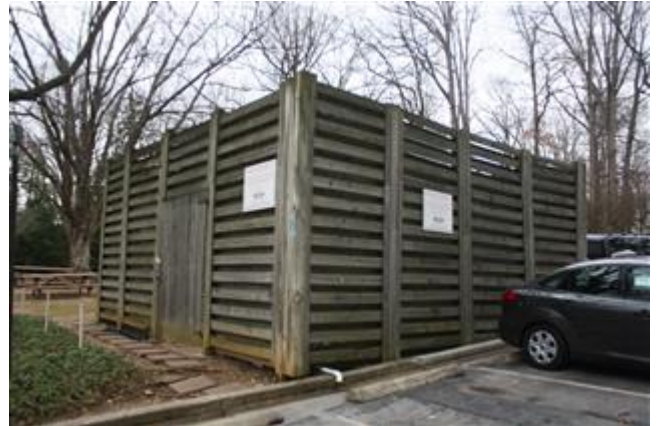
Cooling Tower Enclosure. The building's cooling tower is located on ground level at the rear of the building. The tower is enclosed in a wooden fence. The enclosure needs to be expanded for the new generator.

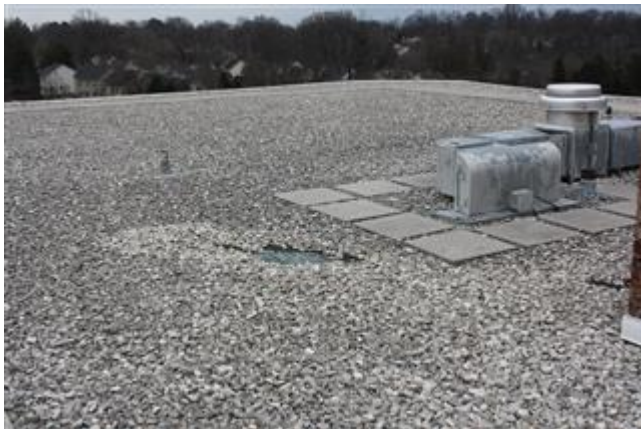
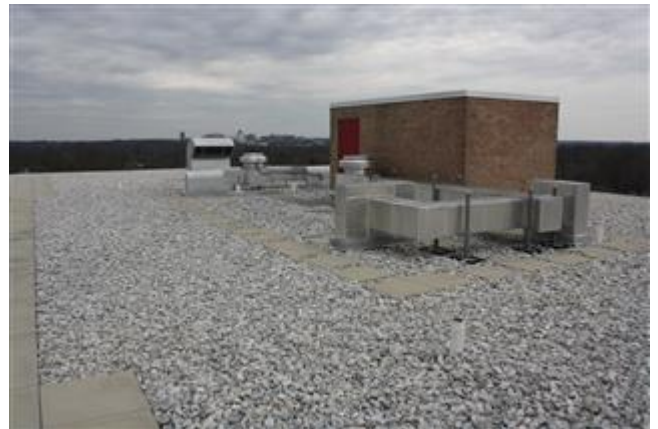
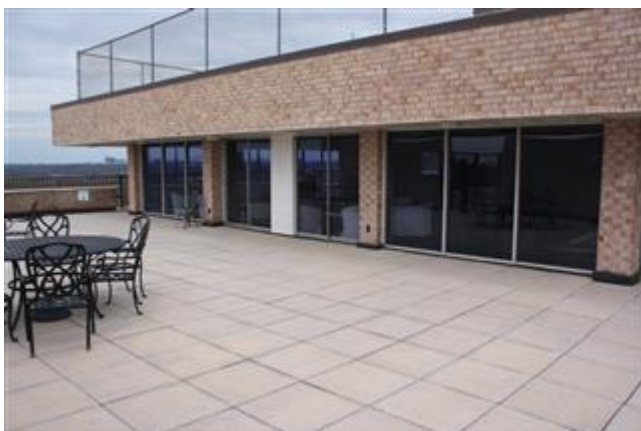
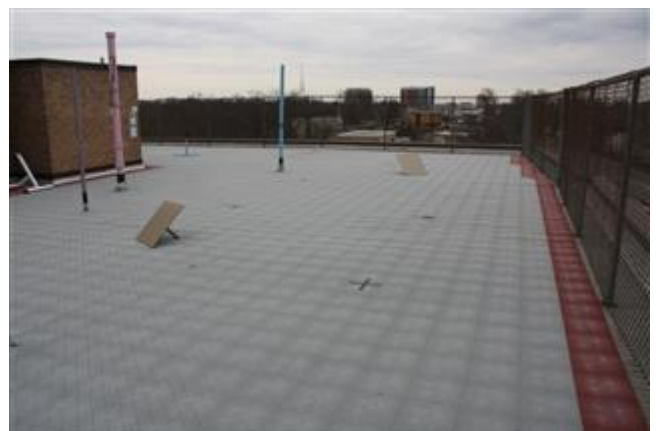
Building Roofing. The building is constructed with both an EDPM and Inverted Roofing system which are in good condition.

Flat roofing systems can have a variety of configurations that will greatly affect the cost of replacement including insulation, ballast, the height of the building, and the density of installed mechanical equipment. Flat roofing systems typically have a useful life of 15 to 25 years.

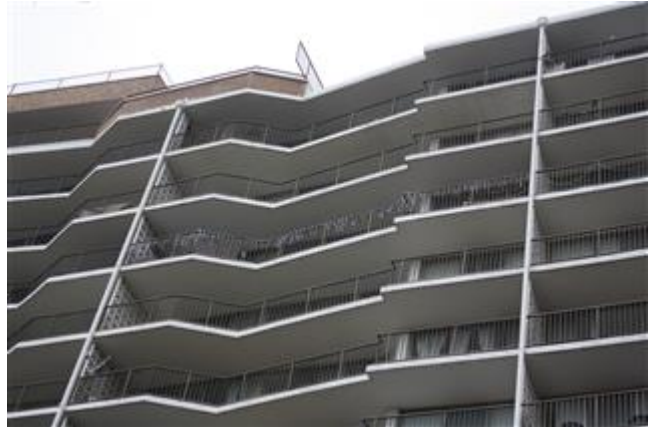
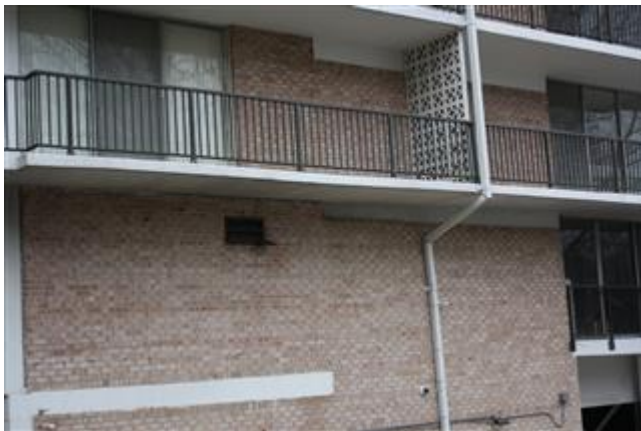
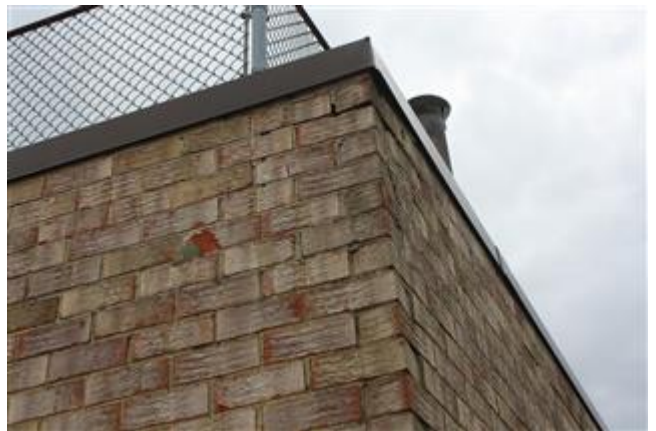
Masonry. The brickwork on the building is in good condition.

Brick masonry is used as an accent exterior cladding of the building. As masonry weathers, the mortar joints will become damaged by water penetration. As additional water gains access to the joints, repeated freeze-thaw cycles gradually increase the damage to the mortar joints. If allowed to progress, even the masonry units such as brick can have their surfaces affected and masonry units can become loose.

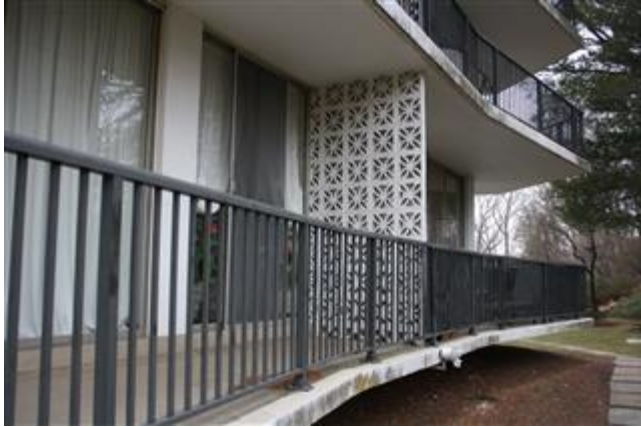
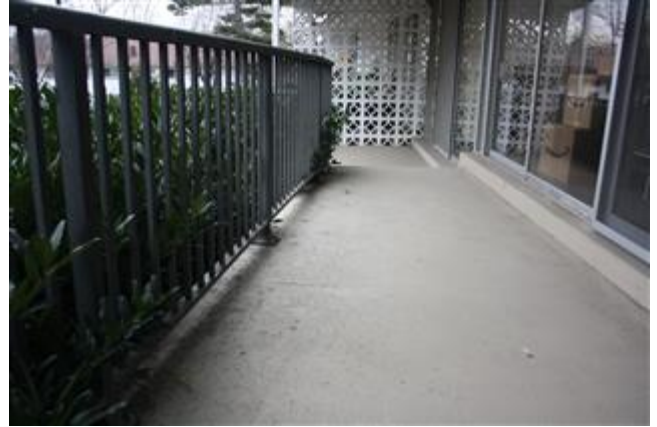
Concrete balconies are prone to deterioration due to their exposure to the elements. This deterioration begins within the concrete and slowly progresses to the surface. By the time, it becomes visible, the damage has been done, and expensive remedial action is typically required.

The leading cause of concrete balcony deterioration is the corrosion of the embedded reinforcing steel. Water penetrates the concrete surface or enters the concrete through penetrations such as railing mounting holes, and when water meets the reinforcing steel, corrosion results. As the steel corrodes, it expands, putting pressure on the surrounding concrete. This pressure will eventually result in cracks, delamination, and spalling. The rate of corrosion is influenced by such factors as the thickness and density of the concrete, the rate of water infiltration, and the installation of carpet or other water-retaining materials on the balcony's surface.

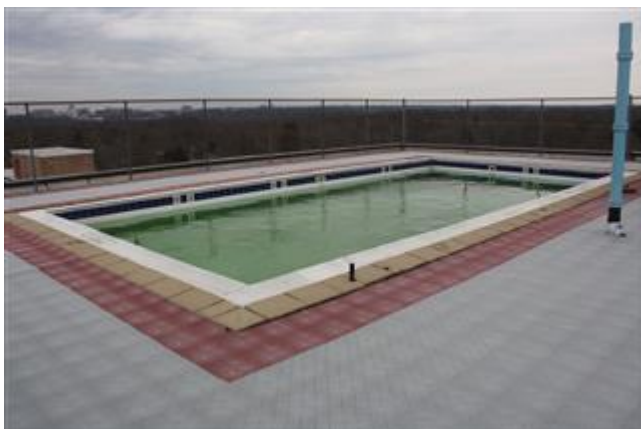
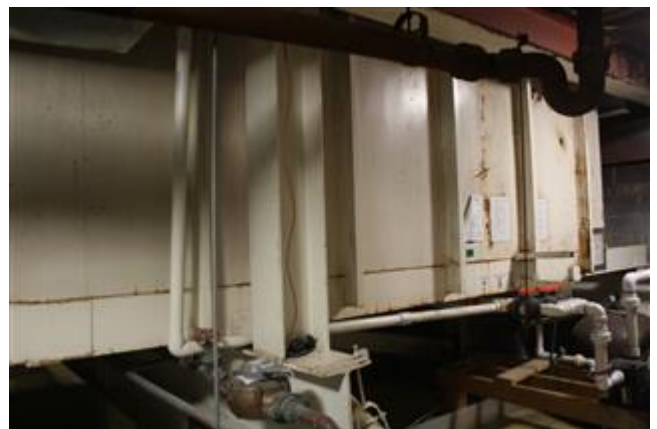
Swimming Pool. The community operates a rooftop steel-framed outdoor pool. Listed below are the major components of the pool facilities:

- Pool Shell. The steel framing shell for the swimming pool is in good condition.
- Pool Deck. The pool deck is an Inverted Roofing System with pavers as the ballast system. There is a plastic mat system on the pavers in the walking area around the pool. The overall condition of the deck is *fair* condition with tripping hazards.
- Fiberglass Coating. The fiberglass coating is in good condition. We have assumed service life of 45 years for the fiberglass coat.

- Waterline Tile. The waterline tile is in good condition. We have assumed that the waterline tile will be replaced or restored when the pool is re-fiberglassed.
- Coping. The pool is edged with precast coping. The coping is in good condition.
- Pump and Filter System. The filter system is in good operating condition.
- Pool Fence. The swimming pool is enclosed by a chain-link fence that is in fair condition.

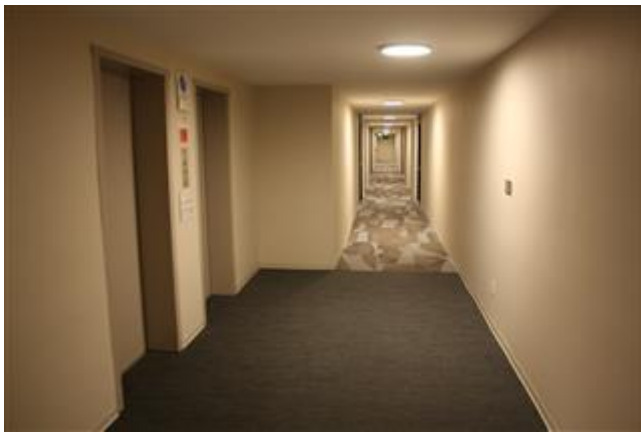
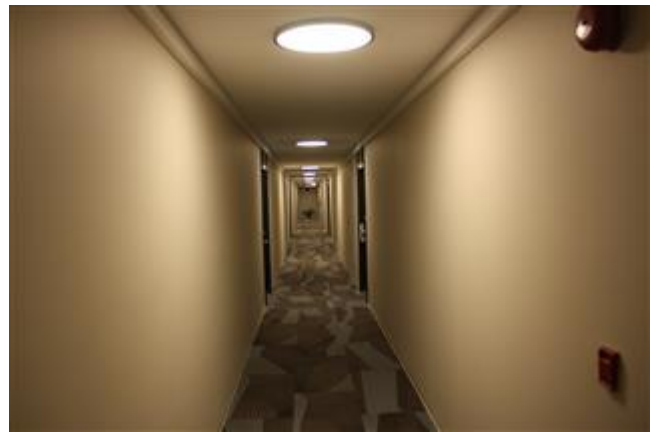
Corridors. The corridors in the building were last renovated 1 year ago. Listed below are the major corridor components that we have included in the Reserve Analysis:

- Carpet. The carpet in the building's corridors is in good condition. The commercial carpet of this construction in this type of application has a typical service life of 7 to 10 years.

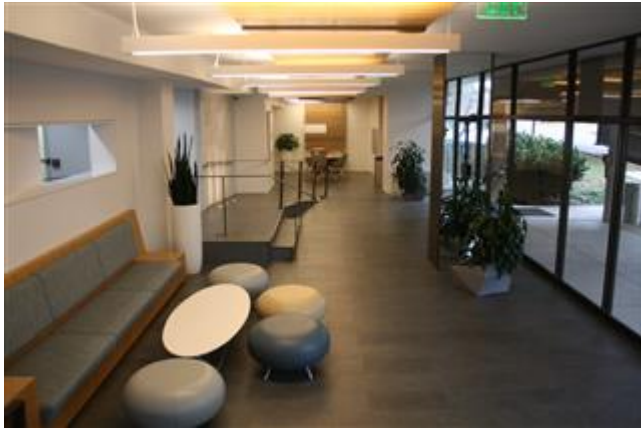
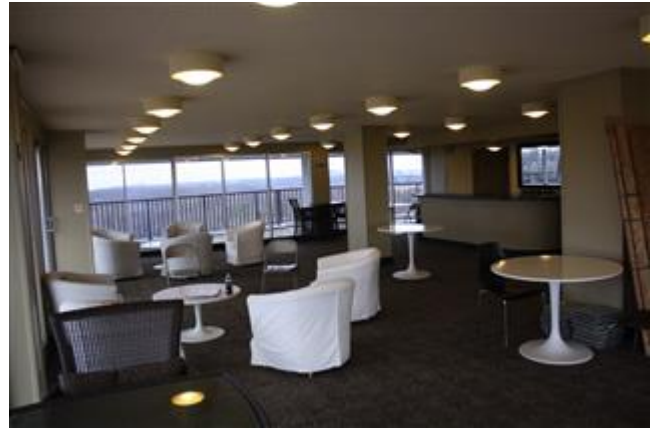
Common Interiors. The Association maintains the Lobby and Penthouse and other common interior spaces. The Lobby has been recently renovated while the Penthouse is in need of renovation.

We have assumed that the Association will want to maintain these areas in a commercially acceptable condition. Typically, replacement cycles for common interior spaces vary between 5 to 10 years depending on the aesthetic tastes of the community, usage, and construction. Material selection and the community's preferences are the major factors in setting the reserve components for items such as refurbishing and interior refurbishment. The Association will need to establish these cycles as these facilities age. Maintaining historical records and incorporating these trends and preferences into a future Reserve Study update is the best way to adjust for these cycles.

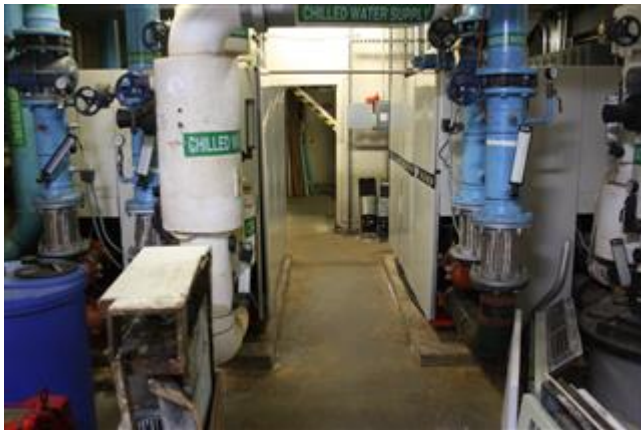
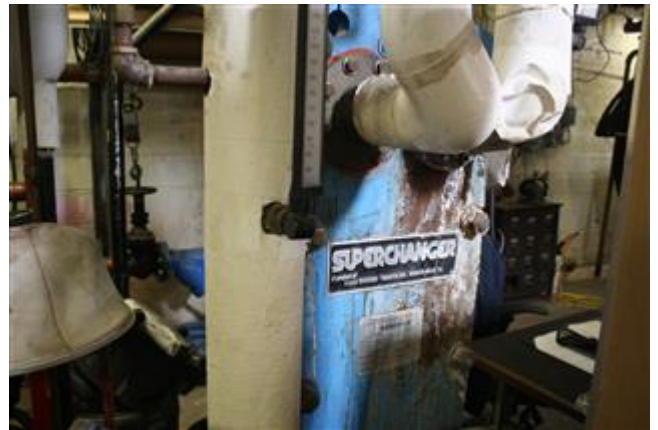
Cooling Tower. The facility has a central cooling system that generates and distributes chilled water to the individual units and other interior areas. Heat from the system is rejected to the atmosphere through the cooling tower system. The cooling tower system is reported to be in fair condition.

Our assessment of the condition of the chiller is based on the age of the chiller, the conditions seen during the site visit, the reported maintenance history of the chiller, and conversations with maintenance personnel.

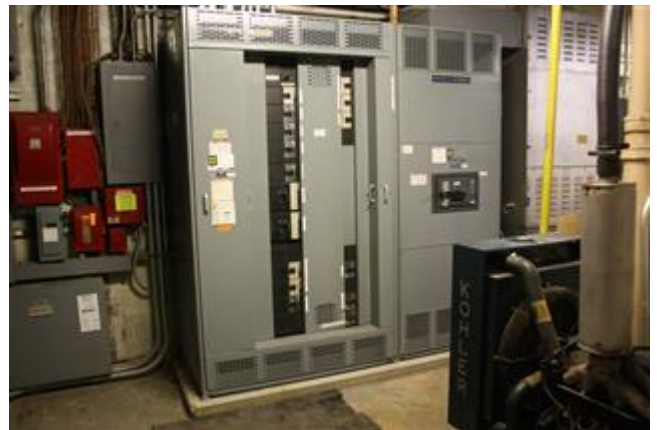
Electrical Switchgear. The electrical switchgear includes the primary distribution equipment, disconnects, relays, fuses, and circuit breakers for the facility. The primary electrical switchgear dates to the original construction of the building. Electrical switchgear has a rated service life of 50 years or more. Electrical switchgear requires ongoing maintenance for proper operation and reliability.

The overall condition of the switchgear is good. We understand that replacement parts are still available for the equipment. As the switchgear continues to age, obtaining replacement parts can be expected to become more difficult. When parts no longer are available or when the condition of the switchgear deteriorates sufficiently, the Association will have to replace or upgrade the existing equipment. Therefore, we have included funding in the Reserve Analysis for distribution panel replacement on an incremental basis.

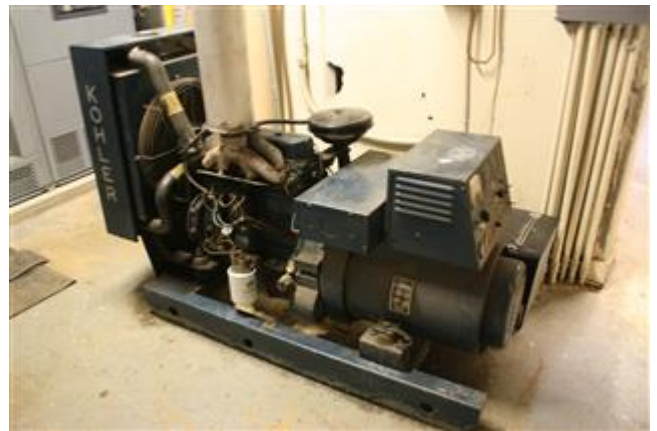
Emergency Generator. The building is served by a 25 kW generator that is located location. The generator is approximately 25 years old and is in fair condition.

The generator does not currently serve the elevators, so a new generator will be installed adjacent to the cooling tower. The generator supplies power to the building's corridor lighting, stairwell lighting, heating system, HVAC system pumps, elevator and, fire pump.
