**LEVEL 2 REPLACEMENT RESERVE REPORT FY 2022
WATERFORD CONDOMINIUM**

WATERFORD CONDOMINIUM

KENSINGTON, MARYLAND

February 26, 2021

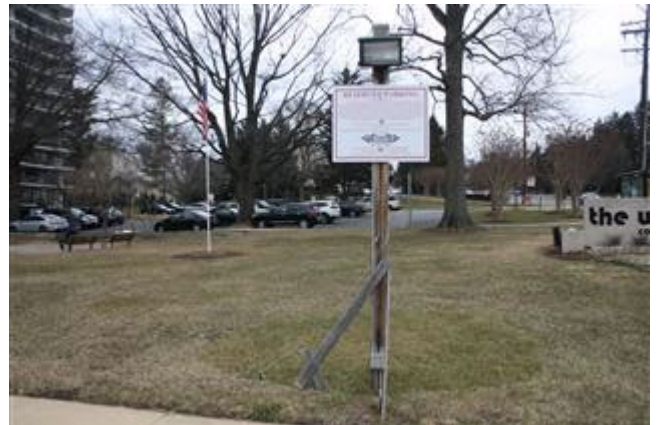
This study assumes replacement of the light fixtures every 15 to 20 years, and pole replacement every 30 to 40 years. When the light poles are replaced, we assume that the underground wiring will also be replaced.

When a whole-scale lighting replacement project is called for, we recommend consulting with a lighting design expert. Many municipalities have design codes, guidelines, and restrictions when it comes to exterior illumination.

Additionally, new technology such as LED and LIFI, among others, is considered. The Association should consider factors such as environmental sustainability, longevity, and cost when they look at the replacement of their lighting.

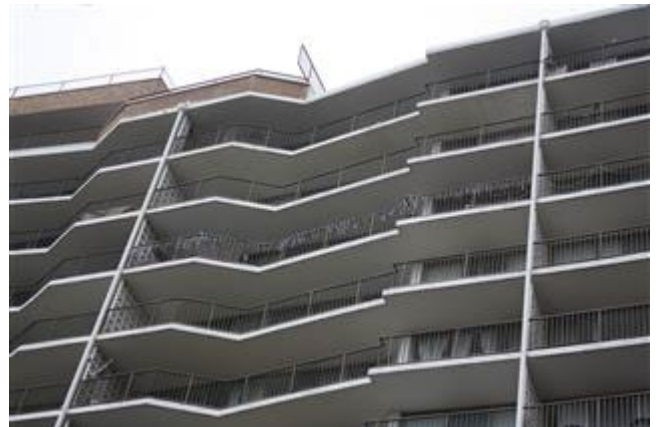
Downspouts. The buildings have downspouts connect to roof scuppers. The downspouts are in good condition.

A downspout system will remove rainwater from the area of the building's roof, siding, and foundation, protect the exterior surfaces from water damage. Downspouts should be securely attached to the side of the structure. Any broken straps should be replaced.

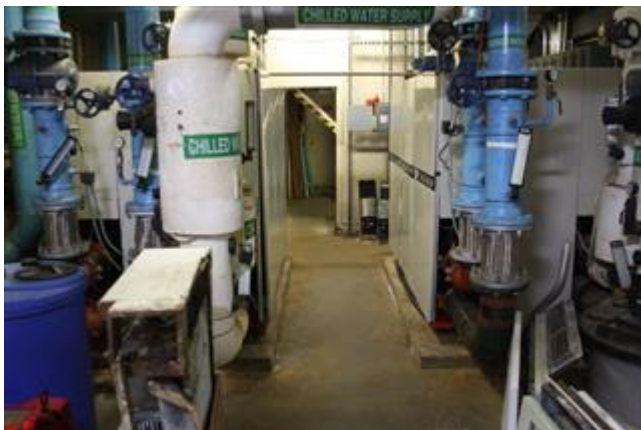
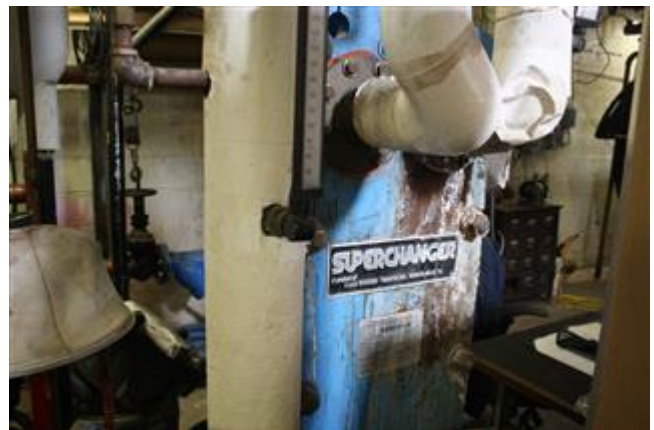
Two banks of scroll chillers supply chilled water to the facility. The chillers are estimated to be approximately 12 years old. Chillers of this type have a typical service life of 20 to 25 years.

Our assessment of the condition of the chiller is based on the age of the chiller, the conditions seen during the site visit, the reported maintenance history of the chiller, and conversations with maintenance personnel.
