LEVEL 2 REPLACEMENT RESERVE REPORT FY 2021 WATERFORD CONDOMINIUM

REPLACEMENT RESERVE REPORT

WATERFORD CONDOMINIUM

KENSINGTON, MARYLAND
February 26, 2021

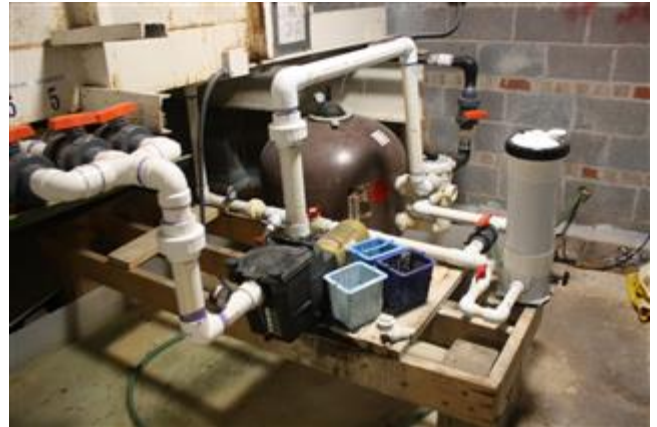
- Pool Shell. The steel framing shell for the swimming pool is in good condition.
- Pool Deck. The pool deck is an Inverted Roofing System with pavers as the ballast system. There is a plastic mat system on the pavers in the walking area around the pool. The overall condition of the deck is *fair* condition with tripping hazards.
- Fiberglass Coating. The fiberglass coating is in good condition. We have assumed service life of 45 years for the fiberglass coat.

- Waterline Tile. The waterline tile is in good condition. We have assumed that the waterline tile will be replaced or restored when the pool is re-fiberglassed.
- Coping. The pool is edged with precast coping. The coping is in good condition.
- Pump and Filter System. The filter system is in good operating condition.
- Pool Fence. The swimming pool is enclosed by a chain-link fence that is in fair condition.

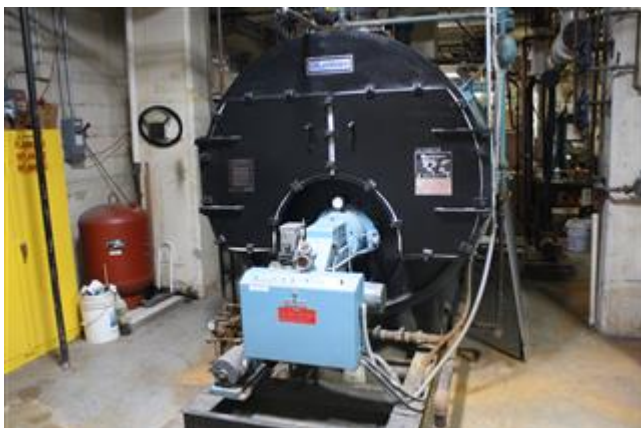
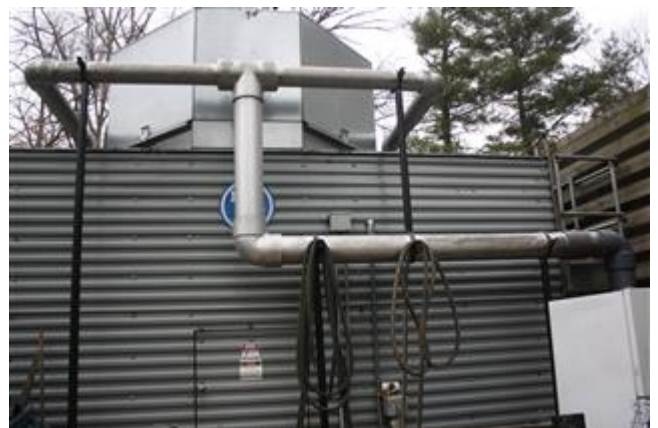
Cooling Tower. The facility has a central cooling system that generates and distributes chilled water to the individual units and other interior areas. Heat from the system is rejected to the atmosphere through the cooling tower system. The cooling tower system is reported to be in fair condition.

Cooling towers have a very large impact on the operating efficiency of a central air conditioning system. Therefore it is important to follow a comprehensive maintenance program to keep the tower operating at peak efficiency. It is also a good practice to replace the cooling tower and chiller systems at the same time. Cooling towers have a typical service life of 20 to 25 years.

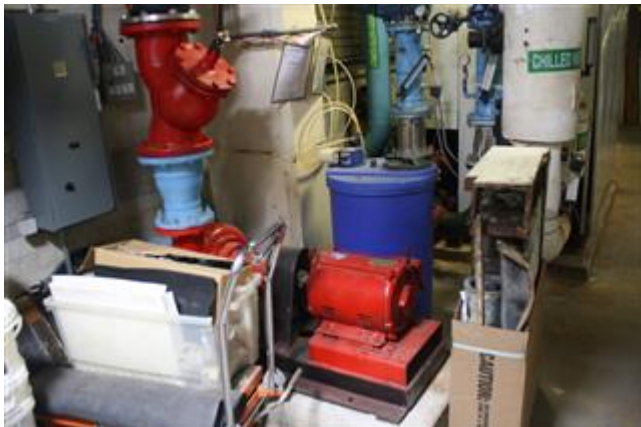
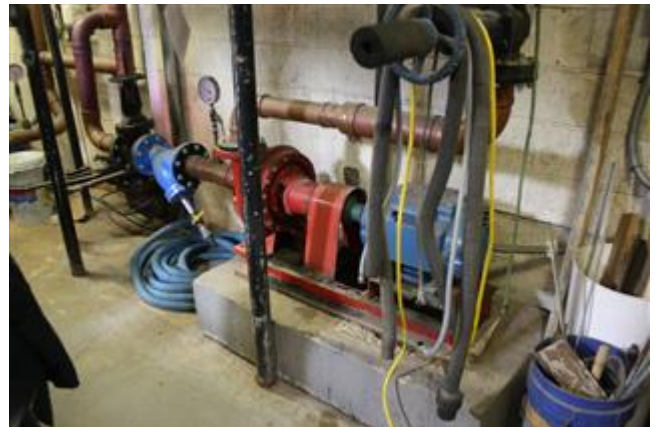
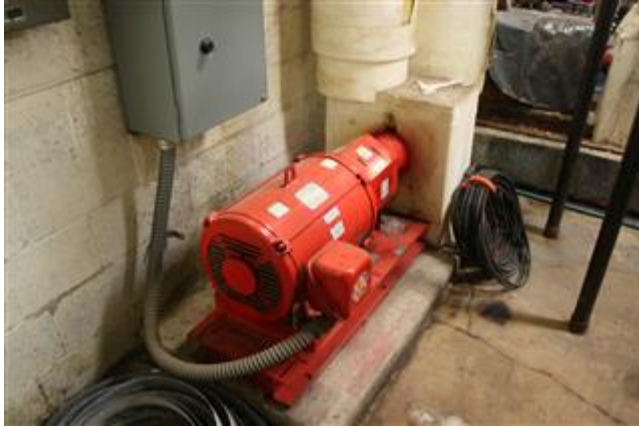
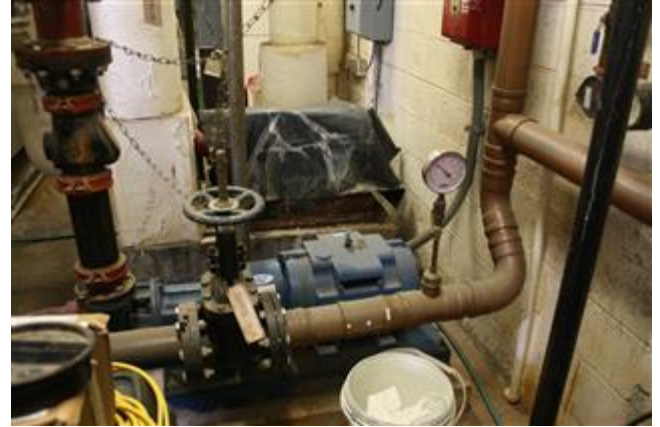
Circulation Pumps. There are four pumps located in the central plant that circulate the building heating, chilled, and condenser water; a 20 and a 40 horsepower pump for heating and chilled water, a 20 horsepower pump for condenser water and a 20 hp standby pump. The study includes replacing the 20 hp pump with a 40 hp. New pumps will be VFD. A standpipe booster pump is also provided.

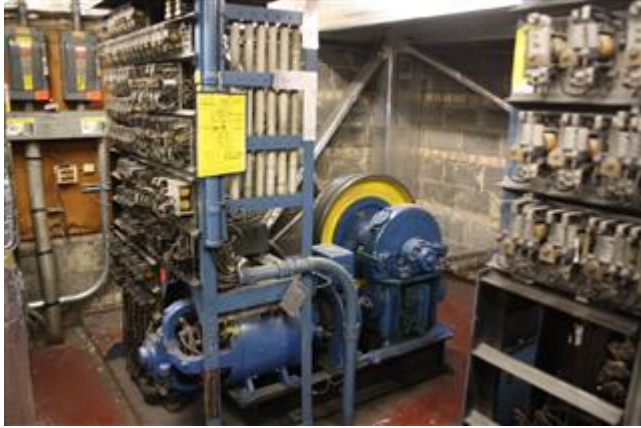
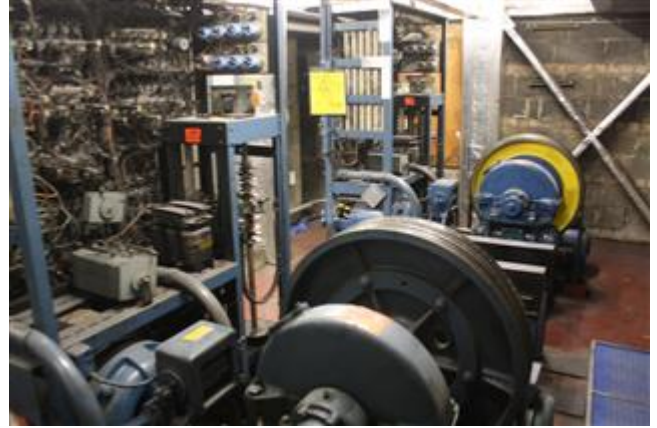
The estimated costs for the replacement of the major components of the facility's elevators have been developed utilizing a combination of sources and guidelines provided by reputable elevator manufacturers and service providers. These costs are included to reflect the obsolescence that occurs with elevator systems. Even though the systems may be functioning well, parts for most mechanical control systems will become increasingly hard to find as the components age, and the reliability of these components becomes problematic. As such, parts availability, down-time, and service costs become major considerations that may force a replacement decision. When these elevator systems are replaced, they will normally have to be brought into compliance with current code requirements. This work typically entails upgrading

door operating mechanisms, replacing elevator call systems, and installation of emergency phones but can involve enlargement of the cab and other very costly work.

Where prudent amounts have been included in this study in anticipation of these concerns, we recommend developing a replacement plan with estimated costs based on the specific equipment installed and current local code requirements. Many reputable elevator companies will provide this service free of charge or at a minimal cost. At the time of a Reserve Study Update, this information can then be incorporated into the study.
